DELLORTO IGNITION SYSTEM HOW TO ASSURE FAULTLESS FUNCTION

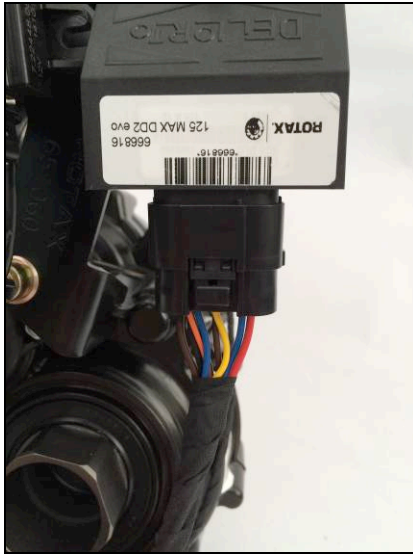
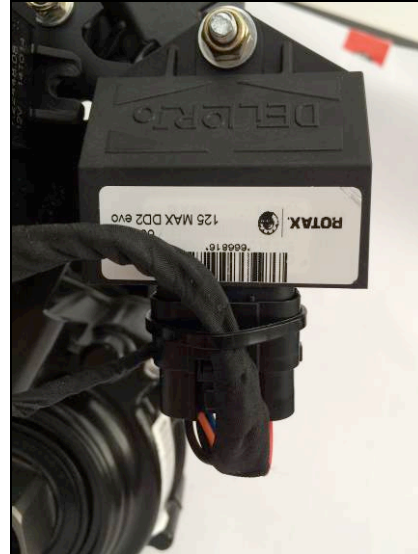
ECU connector

The way the wiring harness is fitted to the chassis can create additional stress to the cables and electrical connections due to the vibration of these components. Out of this electrical cables can break which result in a malfunction of the engine.

It is mandatory to fix the cable harness to the connectors by using cable ties as shown on the following pictures.

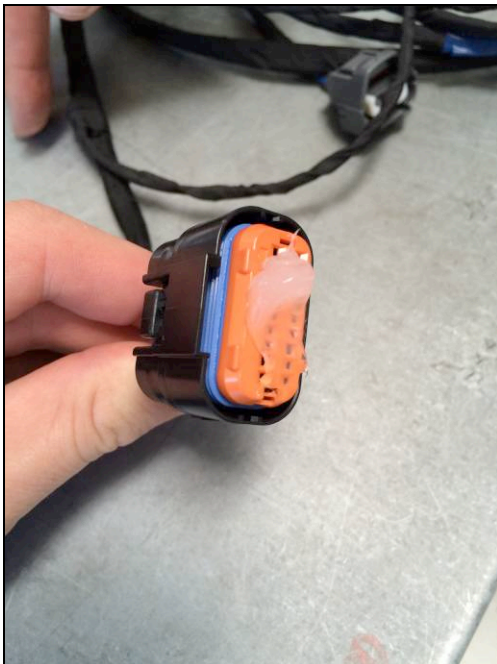
Step 1

The female contact pins inside the connector for the ECU can start lifting up because of vibrations. This can result a temporary contact failure and consequently misfiring of the ignition system.

Apply Molykote 111 (Rotax part no. 897161) and force it into the connector.

The Molykote inside the connector acts as a damping medium for the female contact pins which assures a sufficient electrical contact between female and male contact pins at any time.
