DELLORTO IGNITION SYSTEM HOW TO ASSURE FAULTLESS FUNCTION

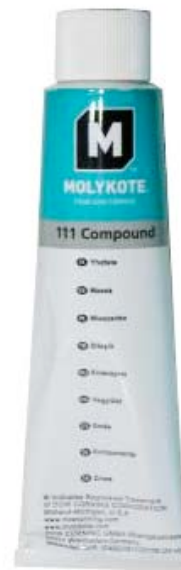
Step 3

The female contact pins inside the connector for the ECU can start lifting up because of vibrations. This can result a temporary contact failure and consequently misfiring of the ignition system.

part no. 897161
